CASE STUDY

TEXAS A&M TESTING

Timber Pile Rehabilitation

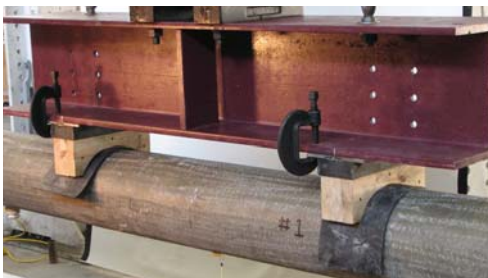
Bending test setup & actuator for the SeaShield Series 400.

2008 Timber Piles Tested in Bending

Test Setup: Six each 8" diameter x 16' long timber piles were tested in bending using a four point bending setup. To simulate deterioration, five of the piles had an hourglass-shaped cut into them at mid-span. One specimen was left undamaged which was used as a baseline control specimen.

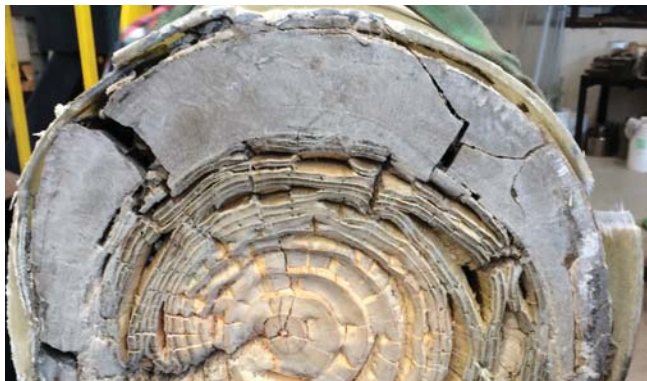
All specimens withstood 3 to 4 times the failure load of the baseline control specimen.

Results: The compressive failure loads of all four pile specimens were significantly higher compared to the baseline control specimen. The average increase in the axial compressive strength was approximately 240%. All specimens withstood 3 to 4 times the failure load of the baseline control specimen.

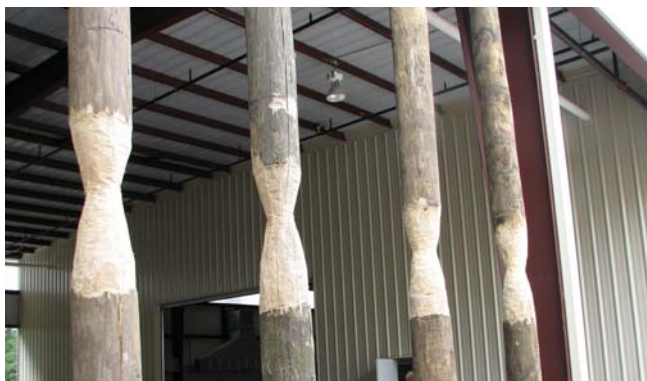
Simulated timber pile hourglass deterioration prior to having the SeaShield Series 400 System installed.

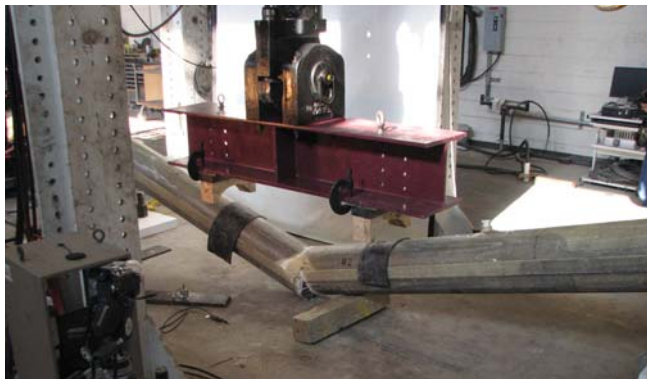
SeaShield Series 400 System at least doubles the maximum load than an undamaged, unprotected timber pile.

Results: The results of the six pile bending tests proved that all repaired piles exceeded the bending strength of the baseline pile by at least double the maximum load achieved by the baseline pile.

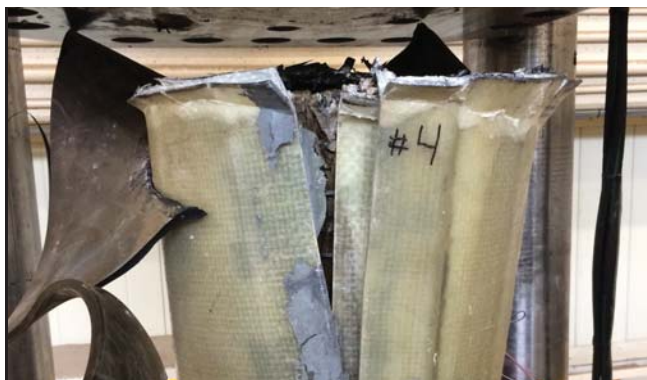
Timber piles installed with the SeaShield Series 400 System were able to withstand a maximum compressive pressure up to 466.6 kips.
